PEDESTRIANIZATION AND NON-MOTORIZED TRANSPORT ISSUE 3: INFRASTRUCTURE

In this pedestrianization series, we started out the **first issue** with examining the demography of pedestrians. This was useful in understanding the profile and needs of the average pedestrian in Nairobi. The majority of the needs that came to light were either safety- or infrastructure-related. Having dealt extensively with the safety-related concerns in the **second issue**, this **third and final issue** in the series will focus on infrastructure and how it affects the pedestrian experience.

A survey using questionnaires, observation and photographs engaged with pedestrians on the challenges they faced on 12 busy pedestrian corridors. The survey was conducted in December 2020 by Nairobi Metropolitan Services (NMS), in partnership with the Climate and Development Knowledge Network.

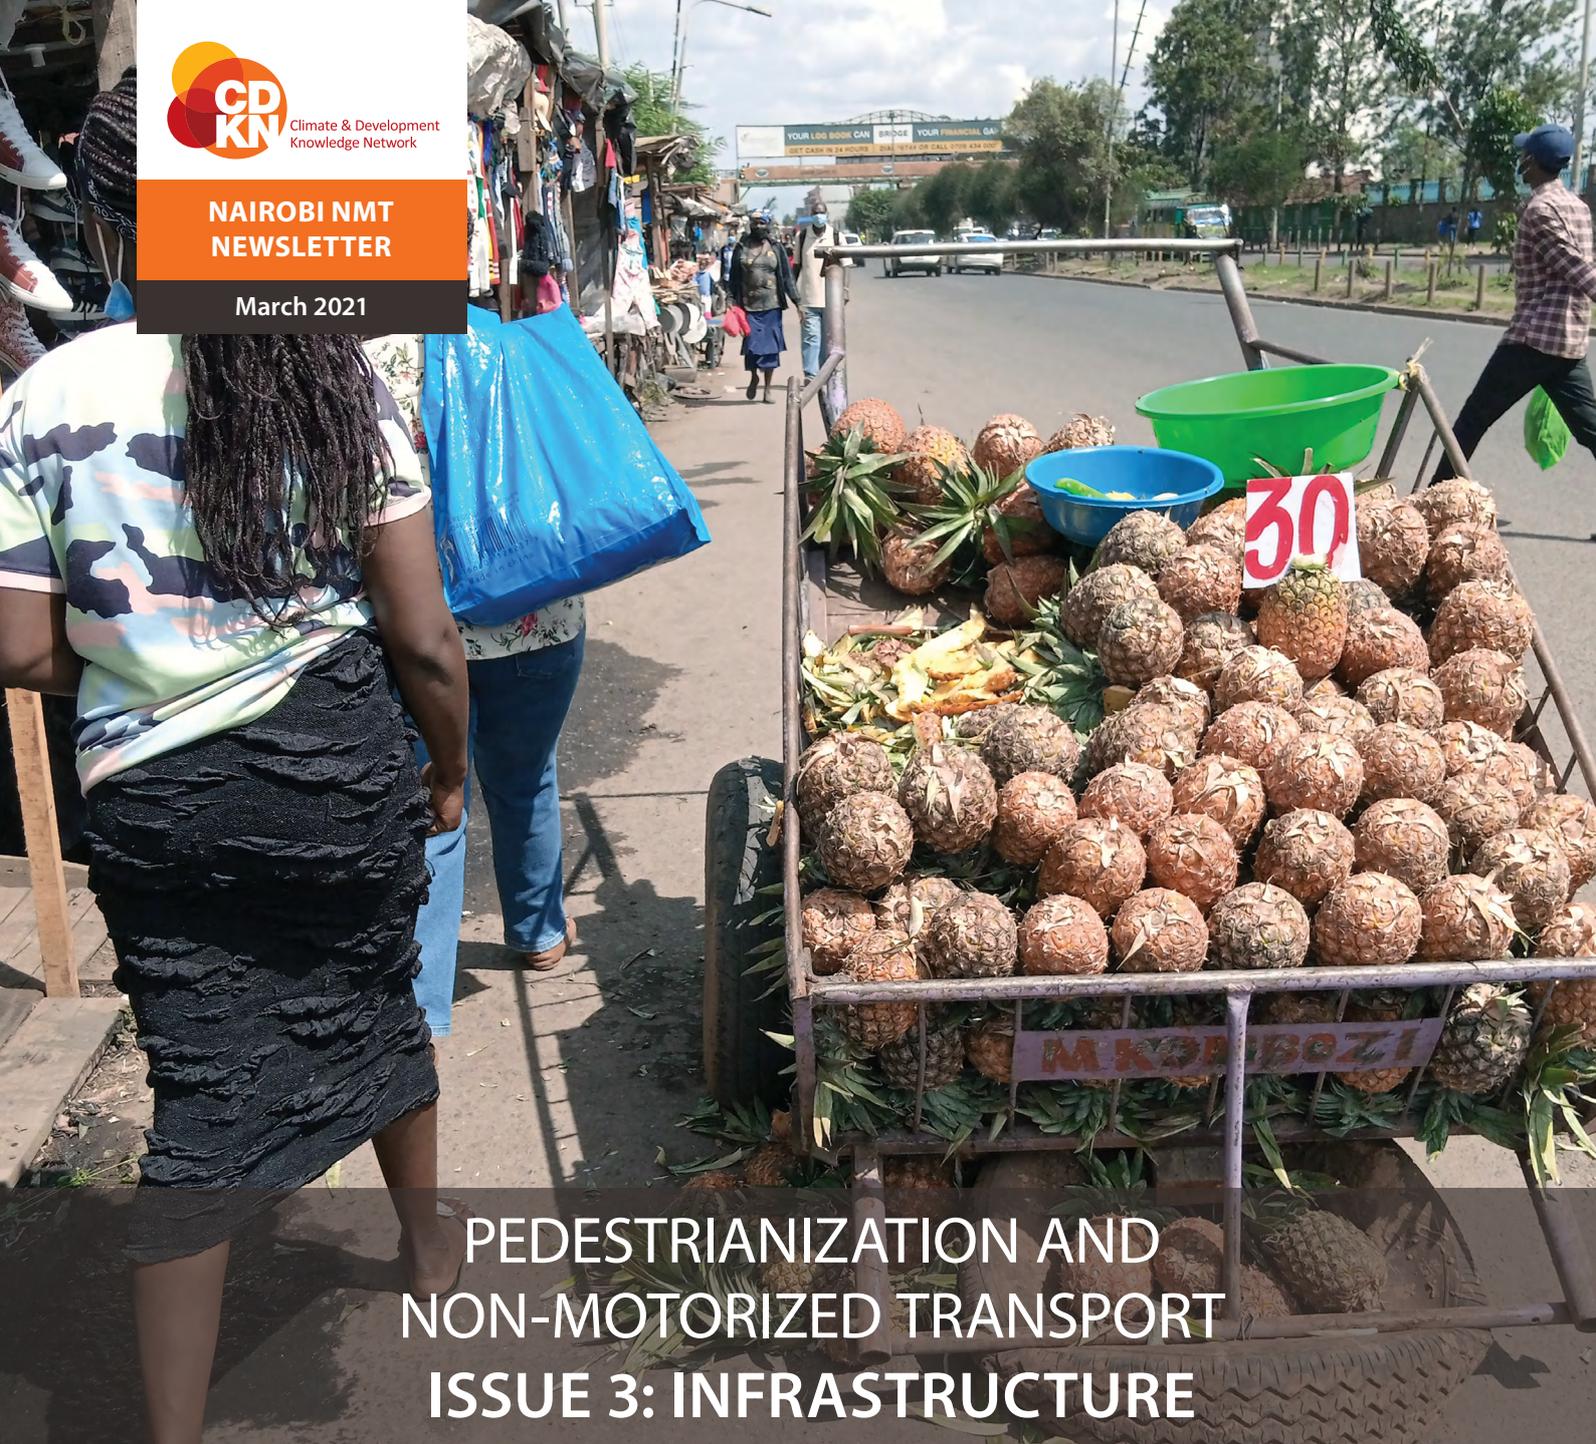
Encroachment of a footpath along Jogoo road. © CDKN

**Encroachment** is rampant on all corridors observed. **The most common forms of encroachment are street vending, cars parked on footpaths and bodabodas using the footpaths.** There are efforts to address encroachment, such as the notice by NMS of harsh penalties for florists, *bodabodas* and vehicles that block footpaths. Street vending is trickier to manage as a form of encroachment. It often seeks to provide essential goods and services. The street design manual states that **well-planned streets should accommodate street vending.** It recommends that vending spaces should be placed where

they will not interfere with pedestrian movement. It also notes that **vendors will be attracted to areas with shade and areas with high visibility to pedestrians.** Supporting infrastructure, such as cooperatively managed water taps, electricity points, litter bins, and public toilets, should also be provided to encourage hygienic practices.

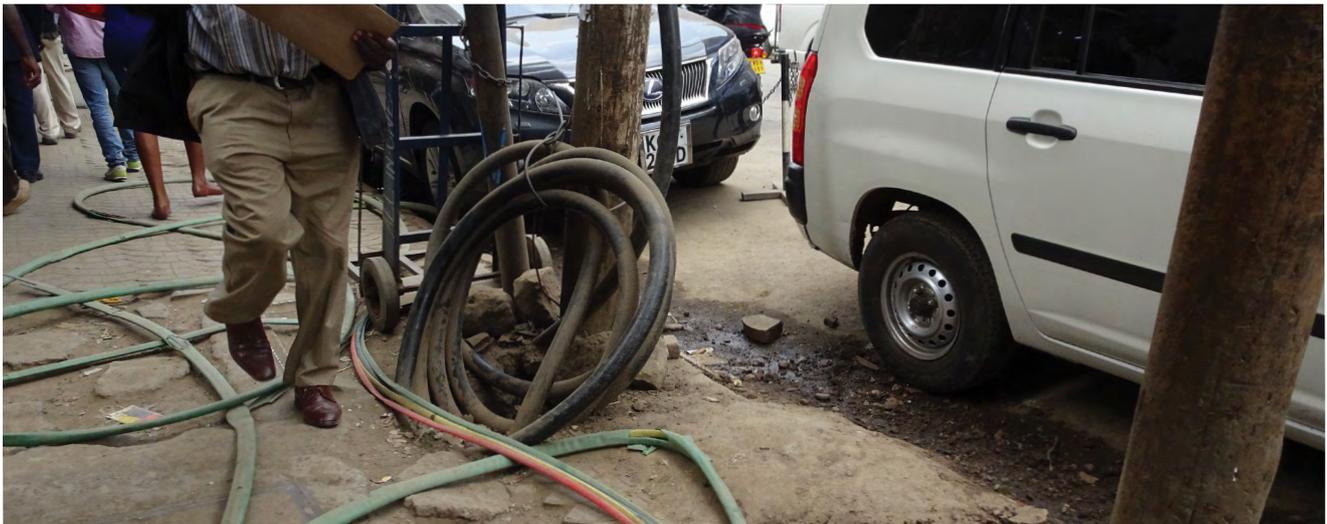
Poorly maintained footpath in downtown Nairobi. © Edna Odhiambo

**All corridors lack adequate and protected footpaths.** In most cases, footpaths have less than two meters of clear space and are, therefore, not compliant with the street design manual's minimum standard requirements. **Footpaths are also not continuous,** forcing pedestrians to walk on the road. Additionally, the **footpaths are not protected by barriers such as greenery on each side,** and most pedestrians feel exposed to the risk of road accidents especially from motorized traffic.
